**Flood Control Project Maintenance
Levee Inspections**
LMA District Cover Sheet
Spring 2017 Levee Inspection Results

Butte County Department of Public Works

Spring 2017 Levee Inspection Results

Waterway			Bank	Unit Miles
Unit No. 01 Mud Creek			Right	6.80
	Spring (March - May)	Summer (June - August)	(September - November) Fall	Winter (December - February)
Unit Maintenance Rating (Fall Only)				
Date of Inspection	4/20/2017 - 4/20/2017			
DWR Inspector	Bob Duffey			
Accompanied By	Shawn Bates Butte County

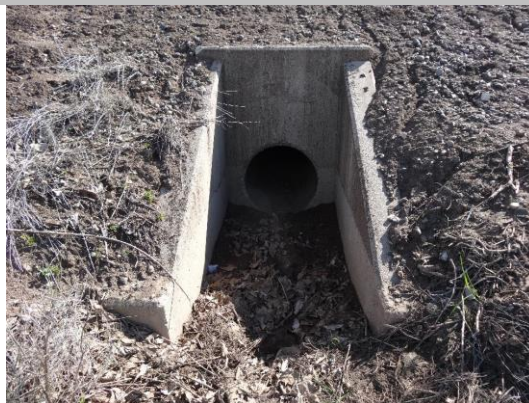
Photo 2 of 3 : UCIP_SP_2017_29705_54923.jpg

LS view: U typed concrete headwall, CMP on levee slope.

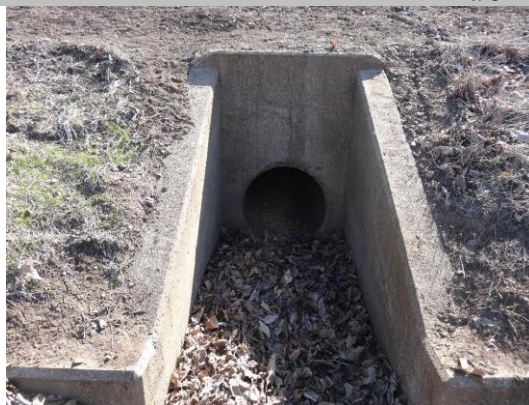
Photo 3 of 3 : UCIP_SP_2017_32044_58541.jpg

LS view: U typed concrete headwall and CMP on levee slope.

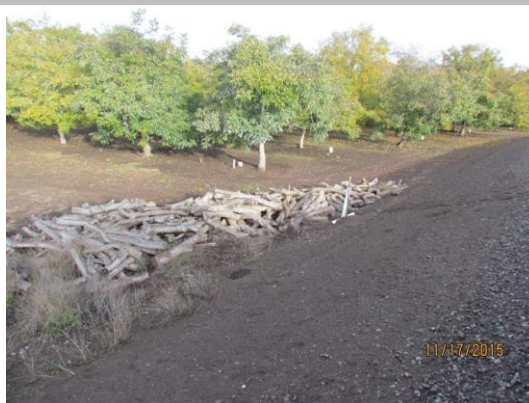
Photo 1 of 1 : SP_2017_NA0003_64_23_20170315_00006.jpg

View of the firewood along the landside toe.

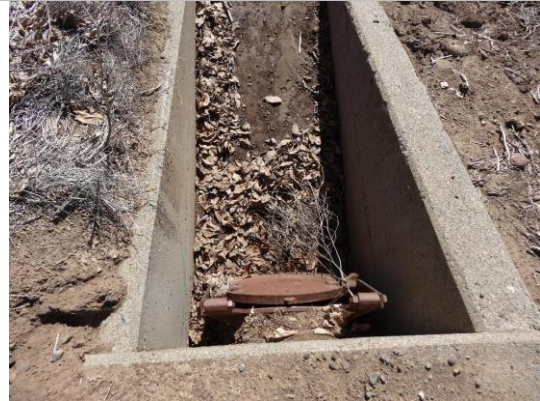
Photo 1 of 3 : UCIP_SP_2017_50142_55886.jpg

WS view: U type concrete headwall, flapgate on levee slope. Gate was not fully closed.

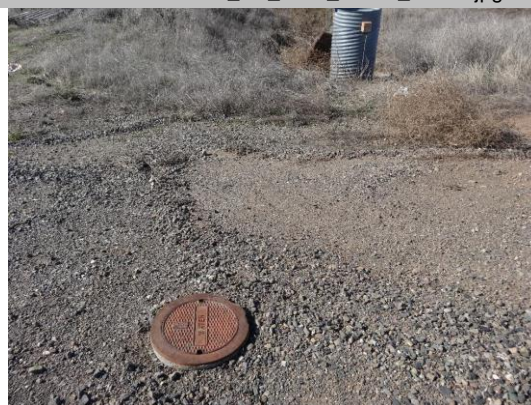
Photo 1 of 3 : UCIP_SP_2017_30291_55700.jpg

LS view: CMP riser on levee toe (top) and control box on levee shoulder (bottom).

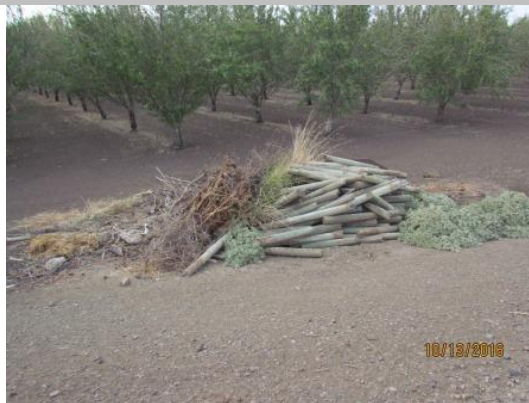
Photo 1 of 1 : SP_2017_NA0003_64_25_20170315_00008.jpg

View of the prunings and wooden posts along the landside toe.

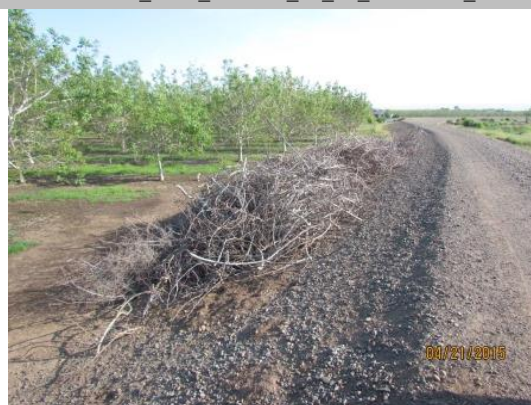
Photo 1 of 2 : SP_2017_NA0003_64_31_20170315_00013.jpg

View of the prunings along the landside slope.

LM Start	3.15	Rating **	M	Issue No.	31
LM End	3.15	Issue Type +	En	Location *	LS
Category	Earthen Levee			GPS Latitude/Longitude	
				Start	End
Item	Encroachments			39.762565 °	39.762565 °
				-121.909873 °	-121.909873 °
DWR ID	DWR_NA0003_01_s_2015_31				
Comment Code					
PR : Prunings					
Inspector Comment					
Remove the prunings from the landside slope.

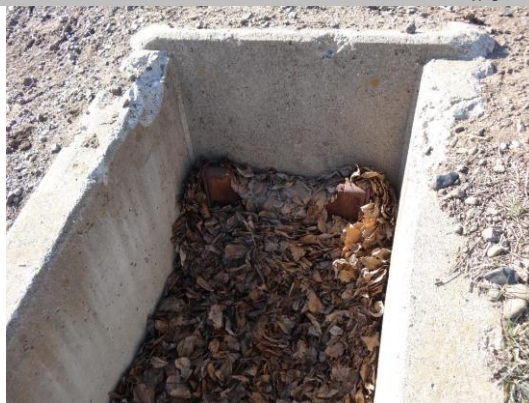
Photo 1 of 2 : UCIP_SP_2017_30295_55706.jpg

WS view: U type concrete headwall, flapgate on levee slope. Vegetation debris blocking the outlet.

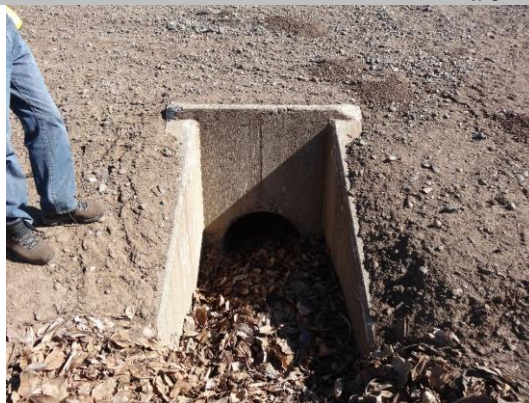
Photo 2 of 2 : UCIP_SP_2017_30295_55705.jpg

LS view: U type concrete headwall and CMP on levee slope. Vegetation debris blocking the inlet.

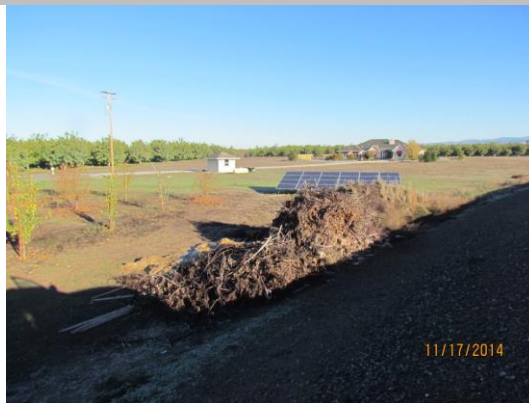
Photo 1 of 1 : SP_2017_NA0003_64_27_20170315_00009.jpg

View of the prunings along the landside toe.

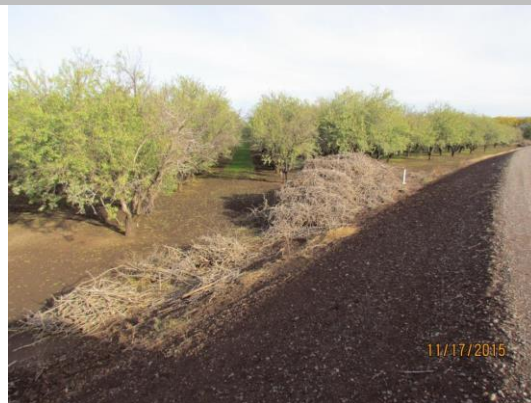
Photo 1 of 1 : SP_2017_NA0003_64_32_20170315_00015.jpg

View of the prunings along the landside toe.

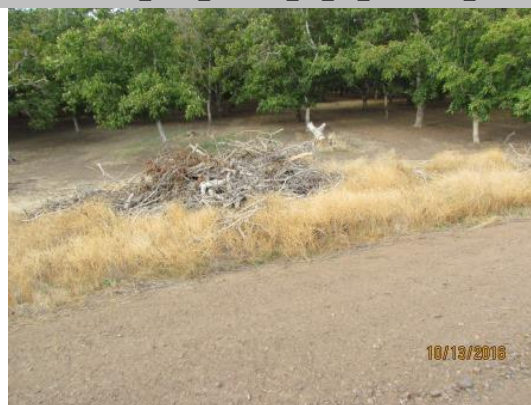
Photo 1 of 1 : SP_2017_NA0003_64_52_20170315_00031.jpg

View of the prunings along the landside toe.

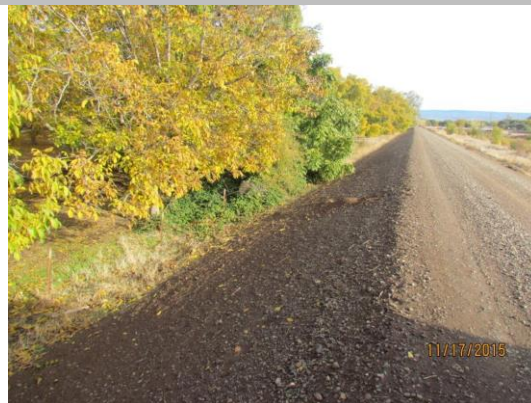
Photo 1 of 1 : SP_2017_NA0003_64_33_20170315_00016.jpg

View of the rodent holes along the landside slope.

LM Start	4.27	Rating **	M	Issue No.	33
LM End	4.27	Issue Type +	Ma	Location *	LS
Category	Earthen Levee			GPS Latitude/Longitude	
				Start	End
Item	Animal Control			39.773398 °	39.773398 °
				-121.895765 °	-121.895765 °
DWR ID	DWR_NA0003_01_f_2015_33				
Comment Code					
A1 : Exterminate rodents and backfill and compact or grout burrows.					
Inspector Comment					
Repair the rodent holes along the landside slope.

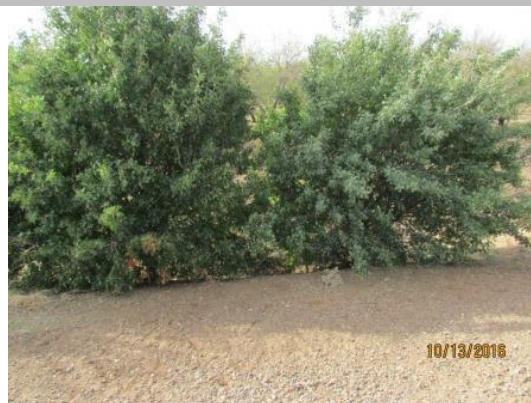
Photo 1 of 1 : SP_2017_NA0003_64_53_20170315_00032.jpg

View of the trees along the landside toe.

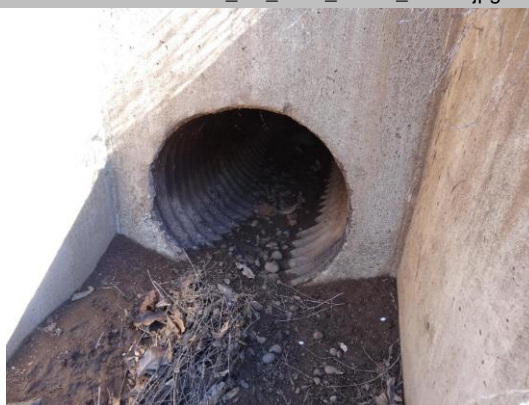
Photo 2 of 2 : UCIP_SP_2017_30312_55744.jpg

LS view: U type concrete headwall and CMP on levee slope. Needs cleaning and clearing of debris.

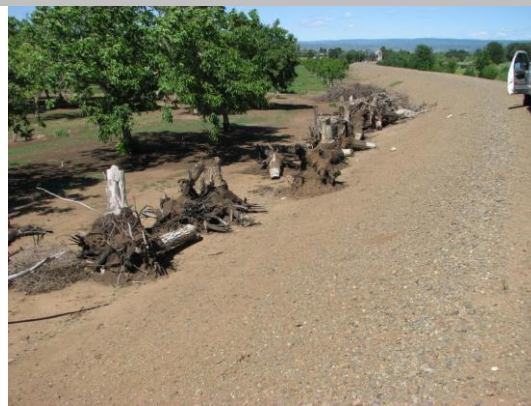
Photo 1 of 1 : SP_2017_NA0003_64_38_20170315_00020.jpg

View of prunings and stumps at the landside toe.

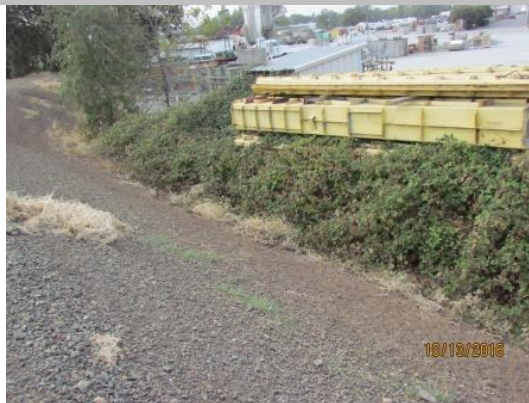
Photo 1 of 1 : SP_2017_NA0003_64_55_20170315_00033.jpg

View of the blackberries blocking visibility and access.

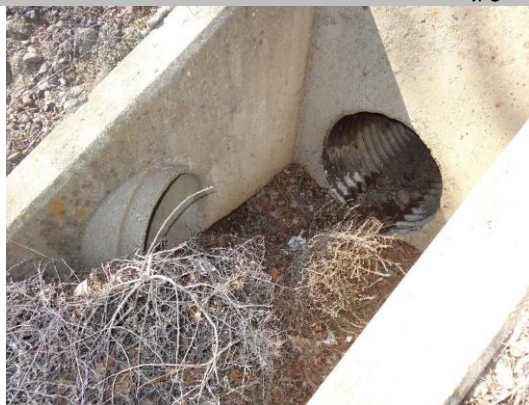
Photo 2 of 2 : UCIP_SP_2017_30743_56640.jpg

LS view: U type concrete headwall and CMP on levee slope. Vegetation debris and soil in inlet area.

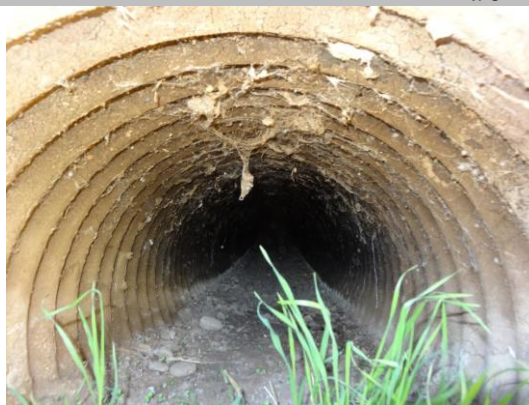
Photo 3 of 3 : UCIP_SP_2017_30763_56660.jpg

LS view: inside view of CMP on levee slope. Needs cleaning and clearing.

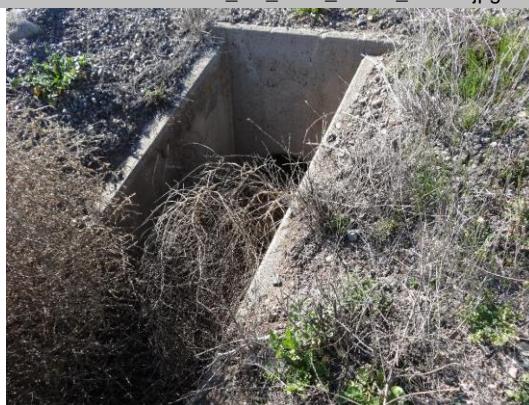
Photo 2 of 3 : UCIP_SP_2017_30803_56684.jpg

LS view: U type concrete headwall and CMP on levee slope. Vegetation debris and soil blocking inlet.

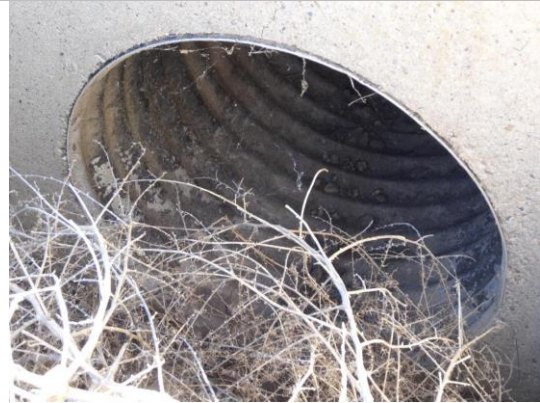
Photo 3 of 3 : UCIP_SP_2017_30803_56683.jpg

LS view: inside view of CMP on levee slope. Needs cleaning and clearing.

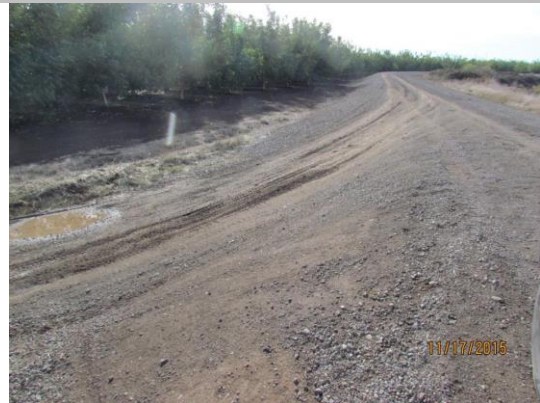
Photo 1 of 1 : SP_2017_NA0003_65_10_20170315_00006.jpg

View of the vehicle erosion along the landside slope.

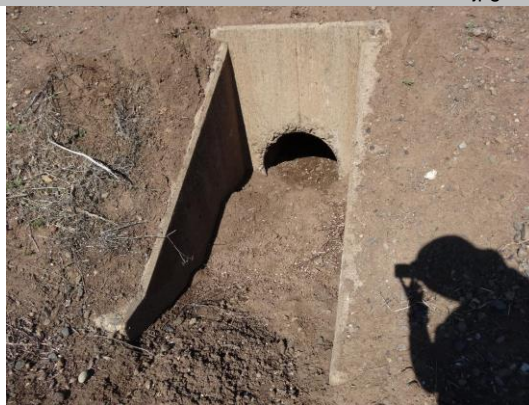
Photo 2 of 3 : UCIP_SP_2017_31031_56916.jpg

LS view: U type concrete headwall and CMP on levee slope. Soil/mud on inlet box.

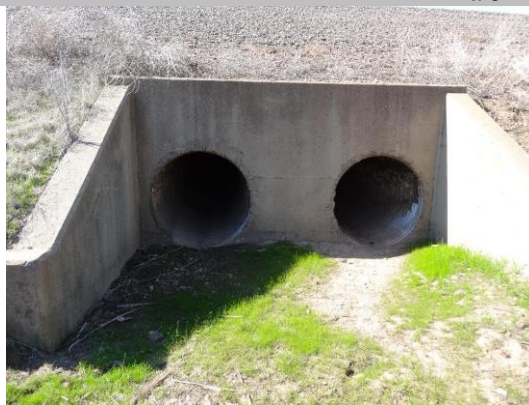
Photo 3 of 3 : UCIP_SP_2017_41376_56918.jpg

LS view: U type concrete headwall and CMPs on levee slope. Soil/mud on inlet box.

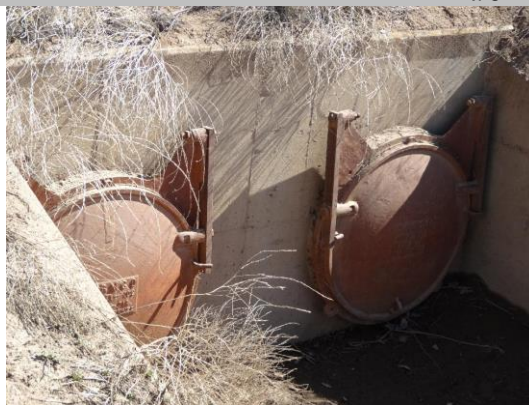
Photo 2 of 3 : UCIP_SP_2017_41377_56922.jpg

LS view: U type concrete headwall and CMPs on levee slope. Vegetation on inlet box.

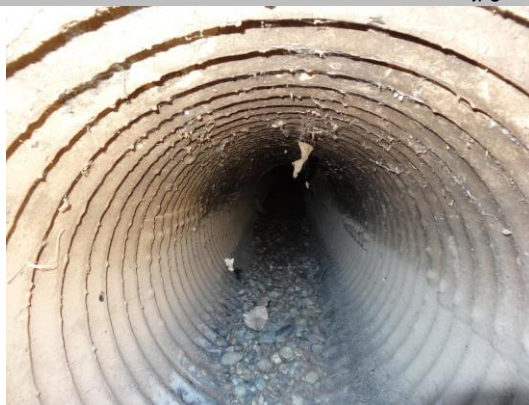
Photo 3 of 3 : UCIP_SP_2017_31034_56924.jpg

LS view: inside view of CMP on levee slope. Needs cleaning and clearing.

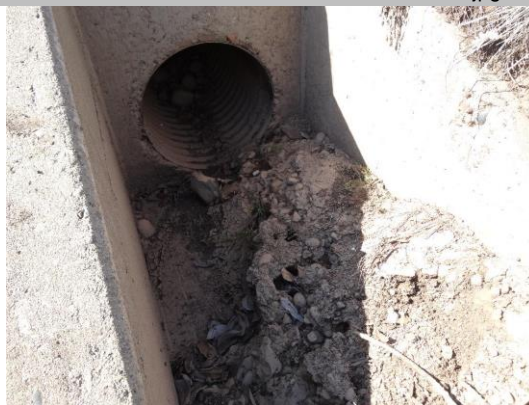
Photo 2 of 3 : UCIP_SP_2017_31085_56987.jpg

LS view: U type concrete headwall and CMP on levee slope. Soil/mud on inlet box.

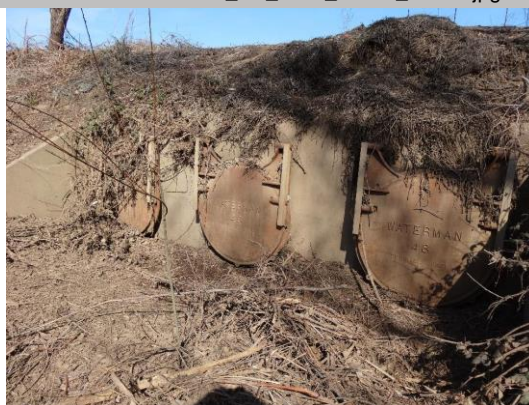
Photo 2 of 3 : UCIP_SP_2017_32085_58584.jpg

WS view: U type concrete headwall, pipes, and flapgates on levee slope.
Soil/mud on outlet box. Vegetation debris blocking outlet box

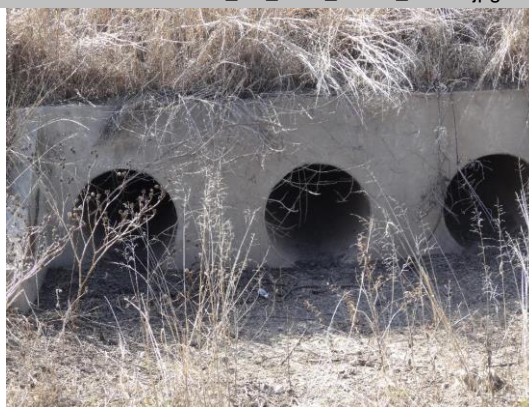
Photo 3 of 3 : UCIP_SP_2017_32087_58590.jpg

LS view: U type concrete headwall and CMPs on levee slope. Soil/mud on inlet box.

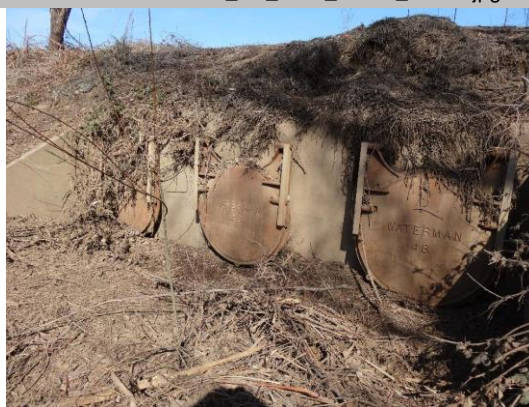
Photo 2 of 3 : UCIP_SP_2017_32086_58588.jpg

WS view: U type concrete headwall, pipes, and flapgates on levee slope.
Soil/mud on outlet box. Vegetation debris on outlet box

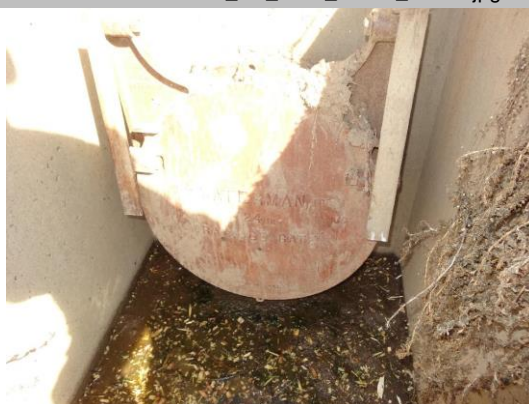
Photo 1 of 2 : UCIP_SP_2017_31129_57036.jpg

WS view: U type concrete headwall, pipe, and flapgate on levee slope. Soil/mud on outlet box.

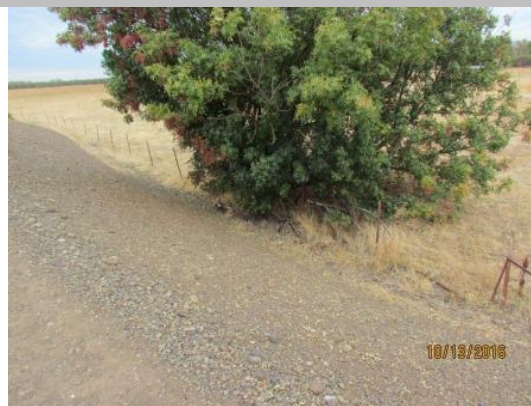
Photo 1 of 1 : SP_2017_NA0003_67_15_20170315_00004.jpg

View of the overgrown tree along the landside slope.

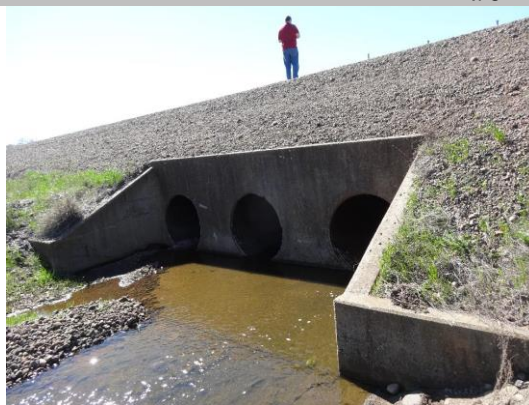
Photo 2 of 2 : UCIP_SP_2017_32104_58605.jpg

LS view: U type concrete headwall and three CMPs on levee slope. Soil/mud on inlet box.

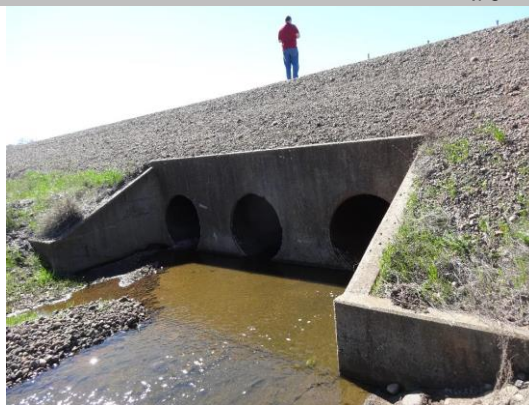
Photo 2 of 2 : UCIP_SP_2017_32105_58607.jpg

LS view: U type concrete headwall and three CMPs on levee slope. Soil/mud on inlet box.

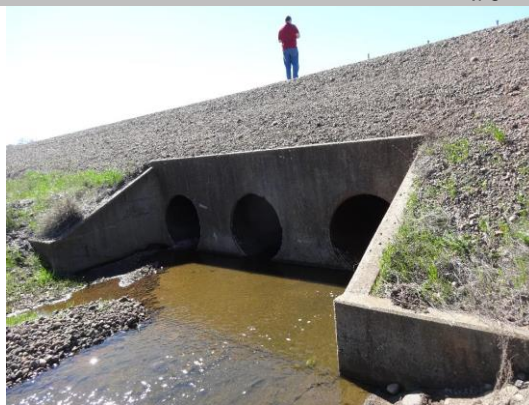
Photo 2 of 2 : UCIP_SP_2017_32106_58609.jpg

LS view: U type concrete headwall and three CMPs on levee slope. Soil/mud on inlet box.

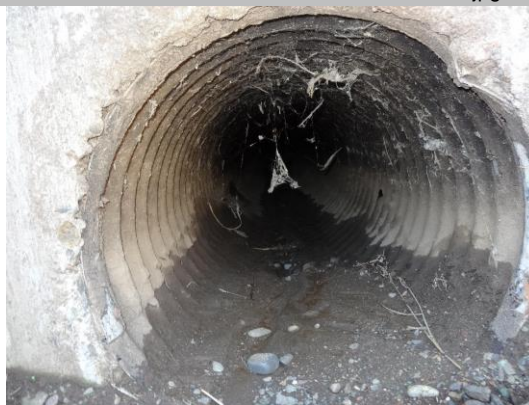
Photo 3 of 3 : UCIP_SP_2017_31901_58195.jpg

LS view: inside view of CMP on levee slope. Needs cleaning and clearing.

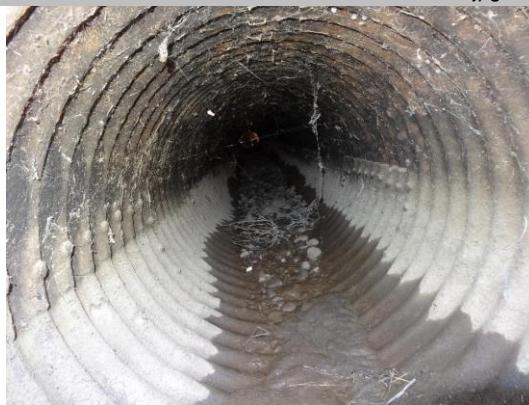
Photo 3 of 3 : UCIP_SP_2017_31864_58067.jpg

LS view: inside view of CMP on levee slope. Needs cleaning and clearing.

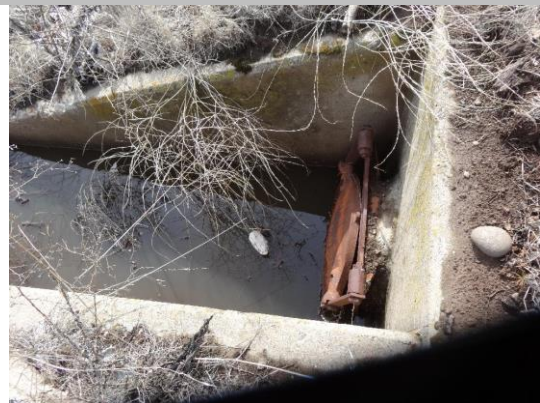
Photo 1 of 2 : UCIP_SP_2017_32125_58629.jpg

WS view: U type concrete headwall, pipe, and flapgate on levee slope. Soil/mud on outlet box. Vegetation debris blocking outlet box.

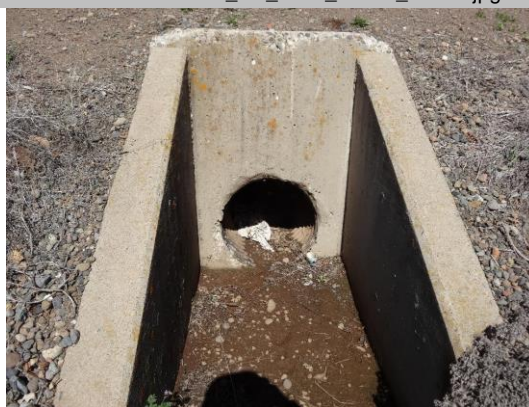
Photo 3 of 3 : UCIP_SP_2017_32026_58518.jpg

LS view: U type concrete headwall and CMP on levee slope. Mud and pebbles on inlet box.

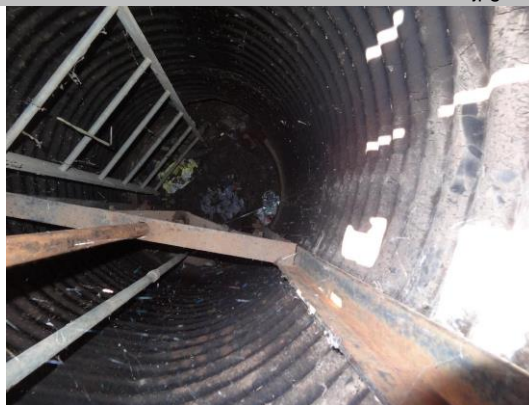
Photo 2 of 3 : UCIP_SP_2017_32025_58511.jpg

WS view: inside view of slide gate in CMP riser on waterside shoulder.
Debris trapped in the riser.

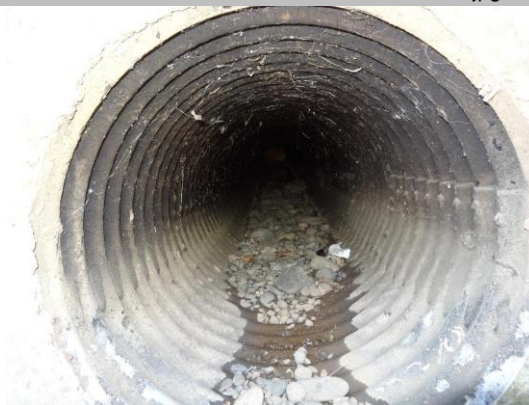
Photo 3 of 3 : UCIP_SP_2017_32023_58503.jpg

LS view: inside view of the CM pipe. Needs cleaning and clearing the pipe.

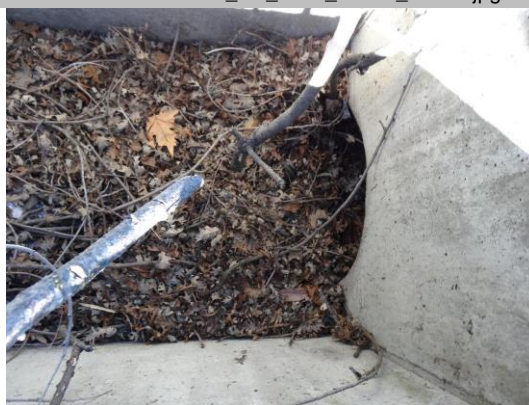
Photo 2 of 3 : UCIP_SP_2017_32144_58643.jpg

LS view: close view of vegetation debris and mud on inlet box.

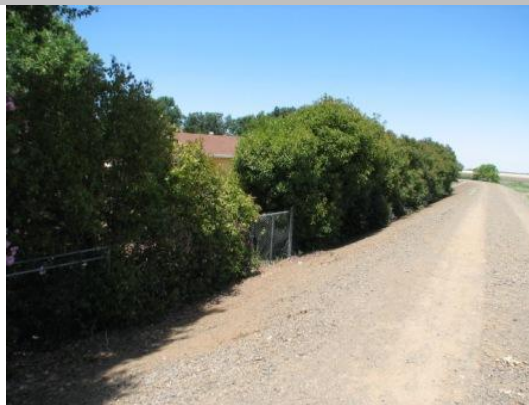
Photo 1 of 1 : SP_2017_NA0003_68_1_20170315_00001.jpg

View of the fence and trees along the landside toe of the levee.

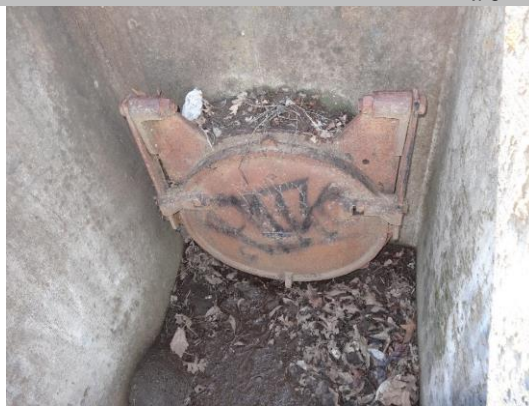
Photo 1 of 3 : UCIP_SP_2017_31963_58384.jpg

WS view: U type concrete headwall and CMP on levee slope. Vegetation debris and mud on outlet box. Needs cleaning and clearing.

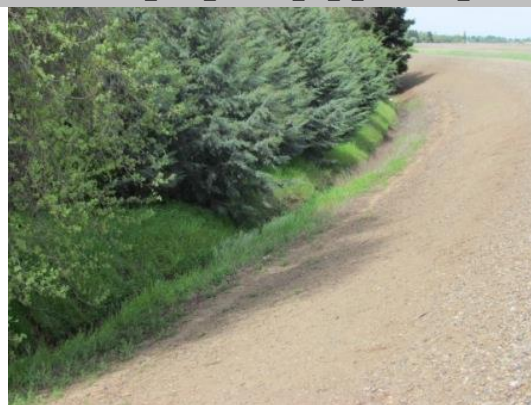
Photo 1 of 1 : SP_2017_NA0003_68_2_20170315_00002.jpg

View of ditch at the landside toe.

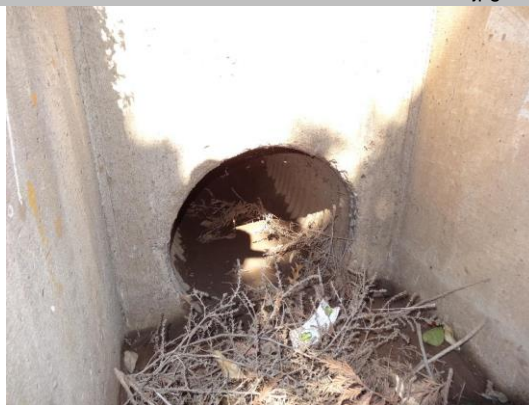
Photo 2 of 2 : UCIP_SP_2017_31964_58388.jpg

LS view: U type concrete headwall and CMP on levee slope. Vegetation debris and mud in inlet box.

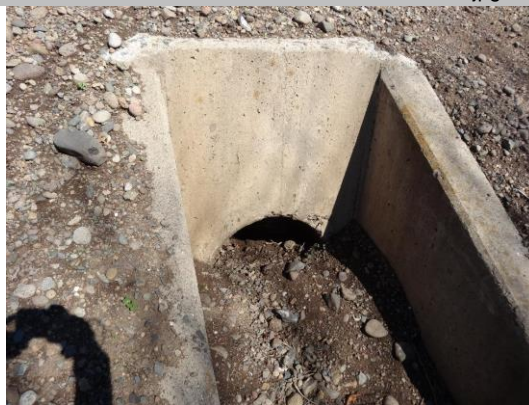
Photo 3 of 3 : UCIP_SP_2017_31966_58399.jpg

LS view: U type concrete headwall and CMP on levee slope. Vegetation debris and mud in pipe and inlet box.

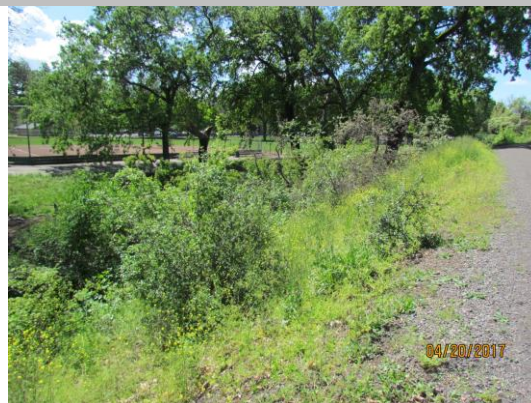
Photo 1 of 1 : SP_2017_NA0003_69_10_20170426_00014.jpg

View of the tree along the landside slope and toe.

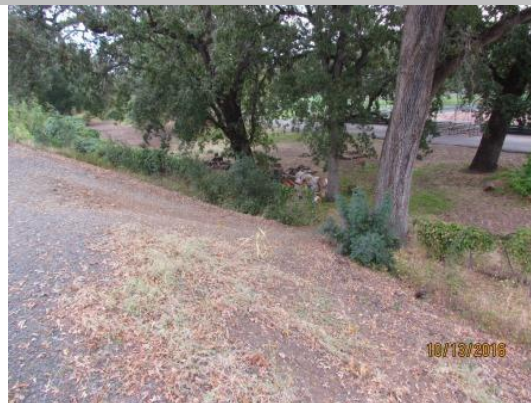
Photo 1 of 1 : SP_2017_NA0003_69_11_20170315_00005.jpg

View of the damaged slope by foot traffic.

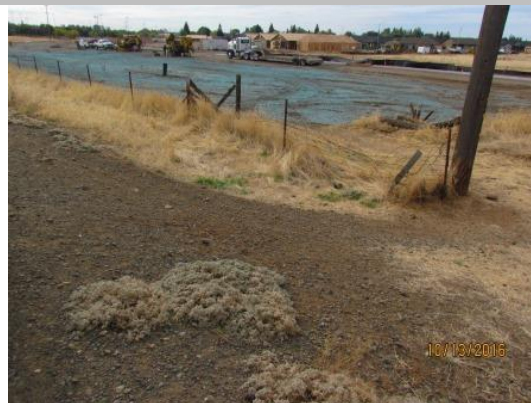
Photo 1 of 1 : SP_2017_NA0003_69_13_20170315_00007.jpg

View of the damaged slope by foot traffic.
